BURGESS INSPECTION GROUP, INC.

PROPERTY INSPECTION REPORT

By: _____ 04/05/2017
(Name and License Number of Inspector) (Date)

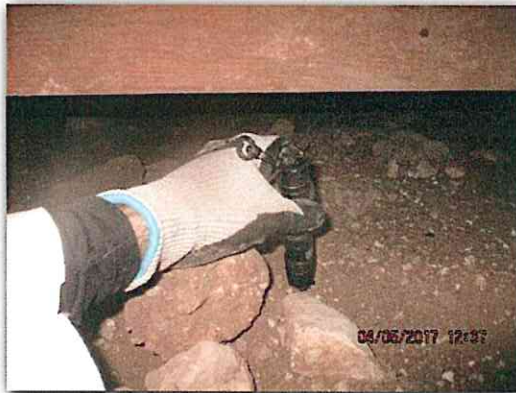
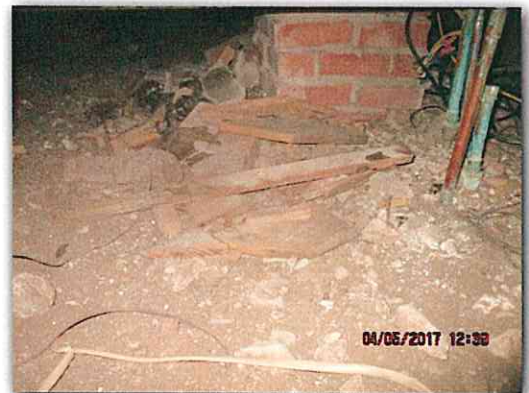
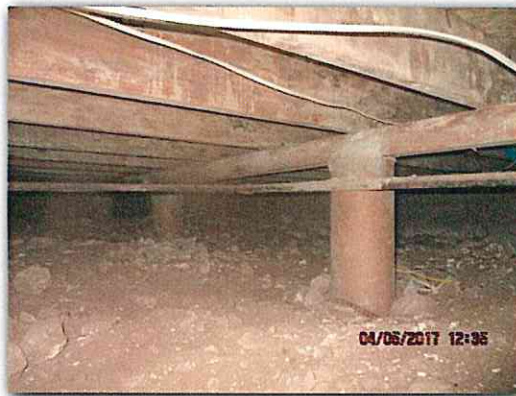
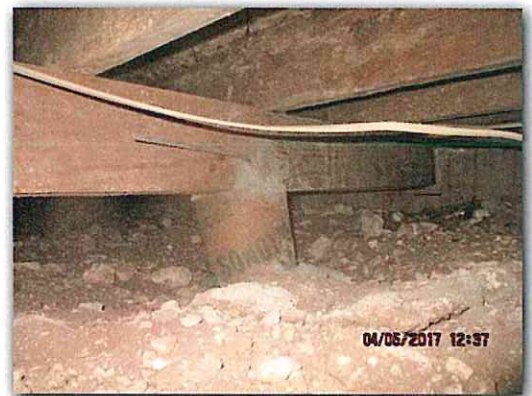
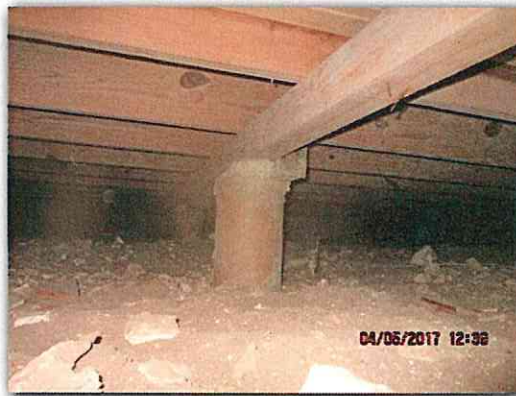
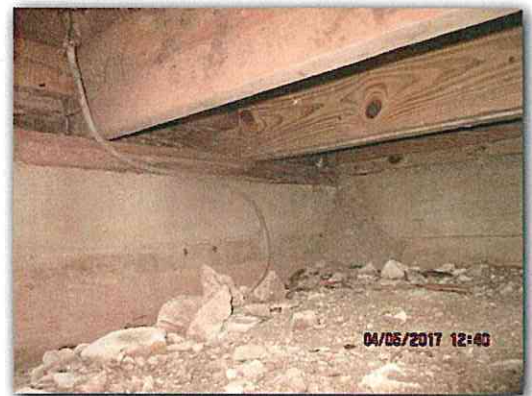
- ✗ Some of the foundation members are too close to crawlspace soil (front side of the house). Generally the floor joists should be 18 inches and girders should be at least 12 inches above soil. Low supports hamper inspections, workers, and can lead to higher moisture exposure.
- ✗ Observed some wood debris in the crawl space. Wood debris is conducive to WDI infestation.

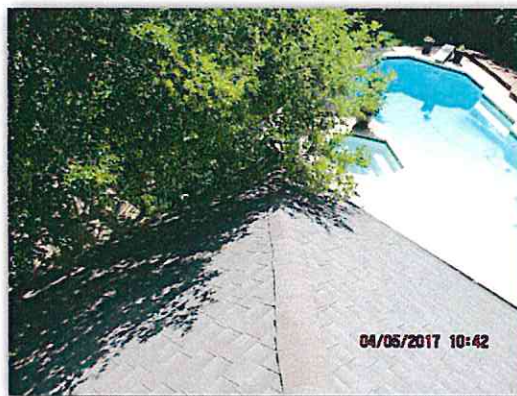
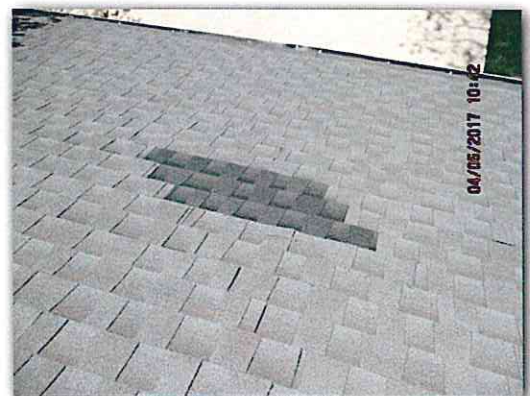
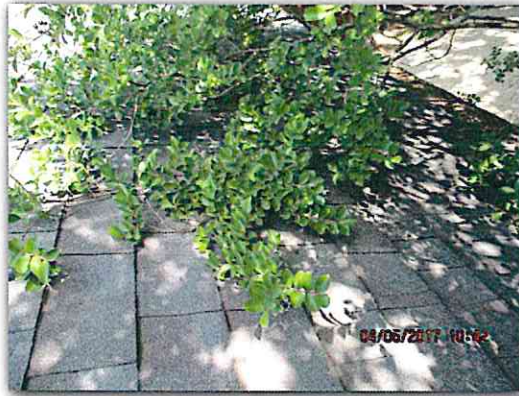
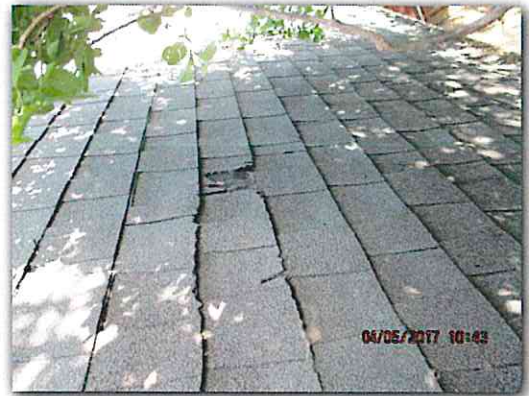
- ✗ Exposed nail heads and/or staples at ridges and/or flashing areas need to be sealed with caulk.
- ✗ Trees near the structure need to be trimmed at least 5 feet away from the roof.
- ✗ Previous patching or repair of the roof at the right side and at the rear side.
- ✗ Observed what appears to be wood shingles used as decking for composition shingles above the detached garage, this is no longer the common practice and it may have insurability issue.
- ✗ The roof appears to be showing signs of age, the shingles feel brittle when walked on..
- ✗ Observed a few damaged shingles at the left side (tree contact).
- ✗ Observed a few damaged shingles above detached garage (ridge area).
- ✗ Recommend having the roof evaluated for condition and/or to discover the cost of possible repairs by a qualified roof specialist.

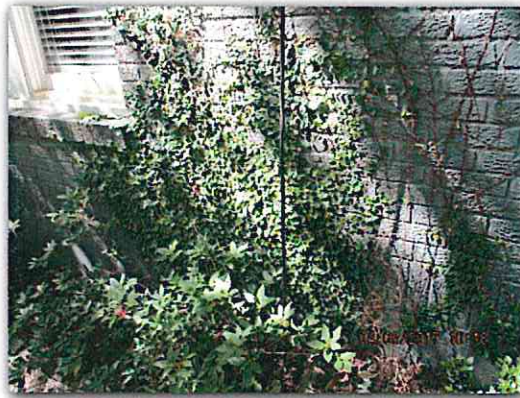
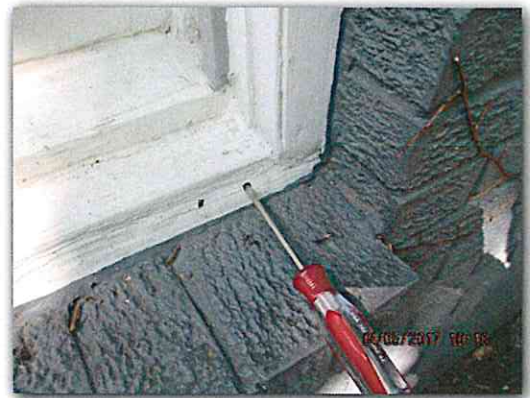
X Keep vegetation away from exterior walls; these are highways for insect and pest infiltration (hedges should be trimmed at least 1 foot away from exterior walls).

X Rot at window trim (left side).

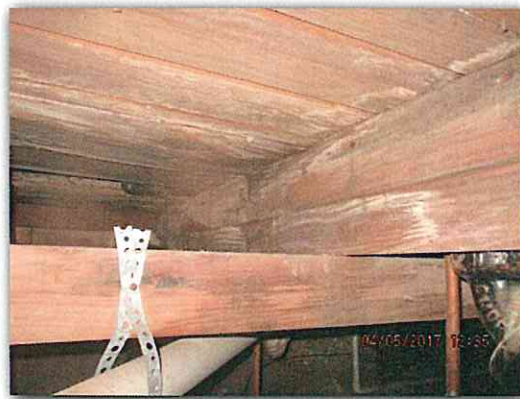
✗ Water stained sub-floor with some possible deterioration of the wood under bathrooms.

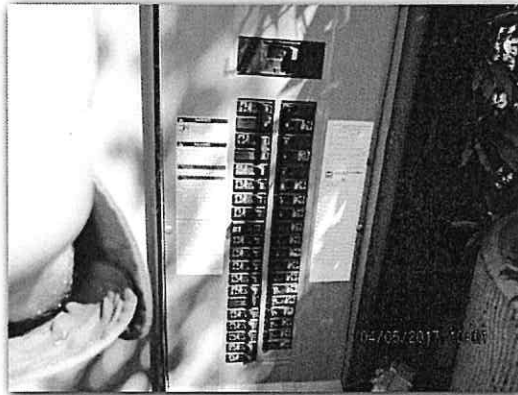
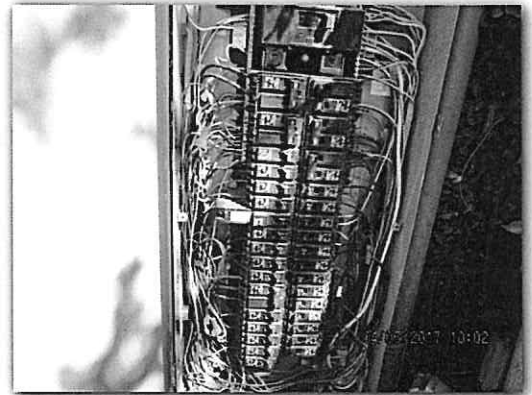
X Some white wires (normally the neutral color) are being used as hot wires (normally black or red) and are not re-identified as hot wires with a black marking of some type (black tape or black marker); miss identified wires can be hazardous to workmen.

X Splices observed in the panel.

X Observed at least two wires "doubled tapped" (two wires under one connection) at a neutral and ground bars.

X Did not observe an exterior grounding electrode rod, (as is now commonly installed) which limits the potential damage or danger to electrical equipment from lightning, line surges, or high voltage crossover. Electrodes also help reduce noise on electrical equipment. (See attached TREC Form OP-I)

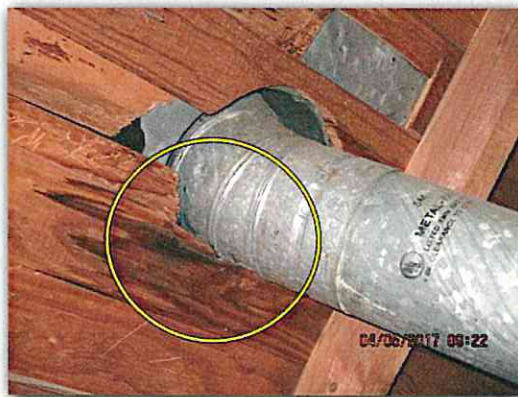
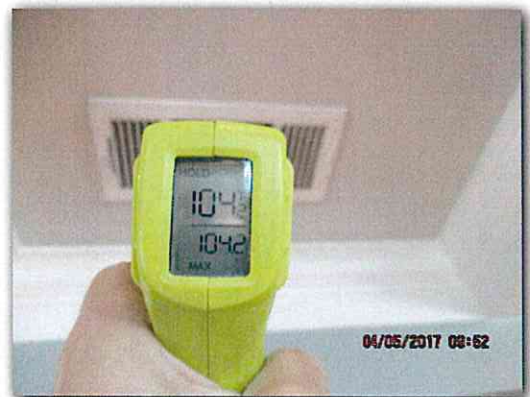
- X The heating unit vent pipe does not have the proper clearance from combustibles where it passes through the roof's wood sheathing and/or wood shingles. A minimum of 1 inch clearance is required.

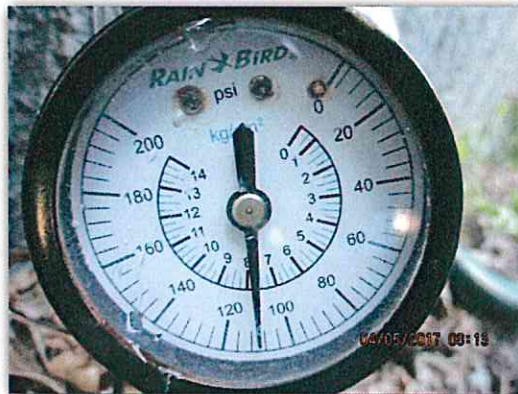
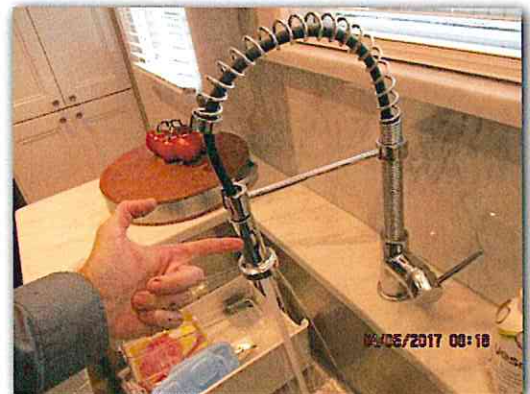
- X Above 80 psi is considered high; the static water pressure reading was 110 psi.
- X Exterior hose faucets (some/all) are not equipped with backflow prevention devices that insure water only flows out and cannot siphoned back into the home. (See attached TREC Form No. OP-1)
- X The kitchen faucet will not go into spray mode (diverter damaged).
- X Master bath commode "runs" (water not completely shutting off all the time), ballcock and flapper should be checked.
- X No sink drain stopper in place at the laundry room.

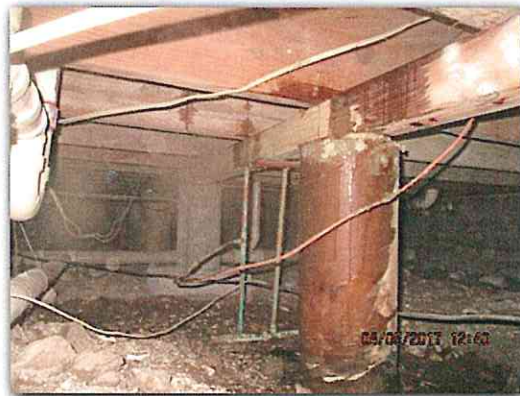
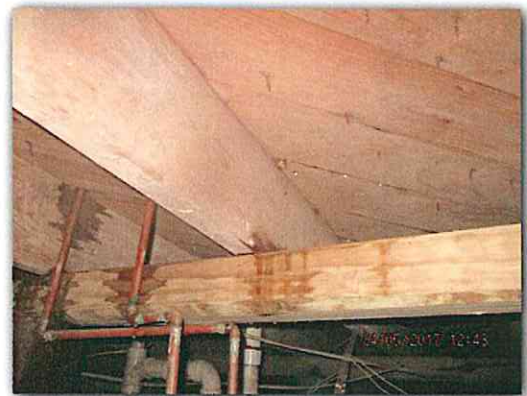
- X Water seen dripping from the floor, in the crawlspace under the master bathroom.
- X Leak at the drain pipe under master bathroom sink (left sink), leak will only present itself when filling the sink with stopper.
- X Recommend having the plumbing checked/repared by a qualified, licensed plumber.

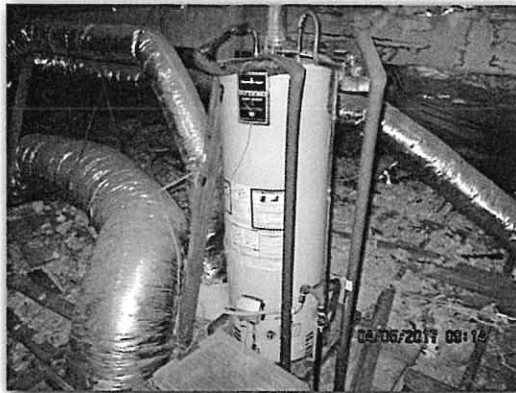
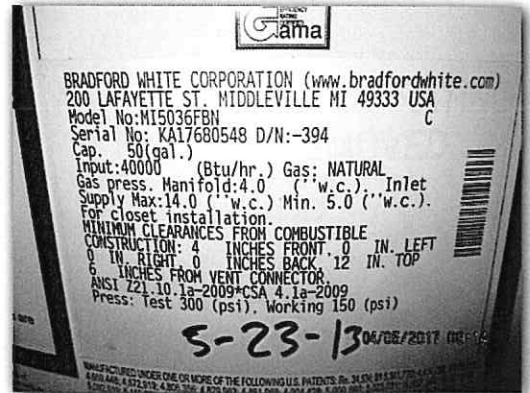
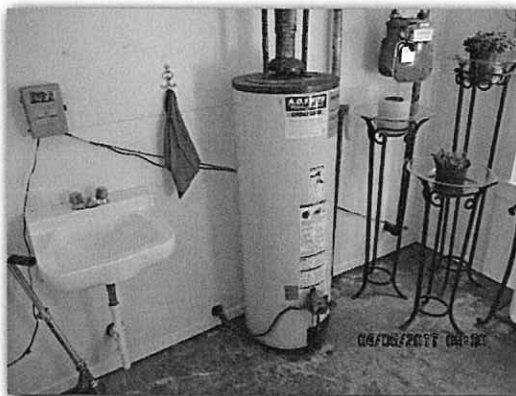
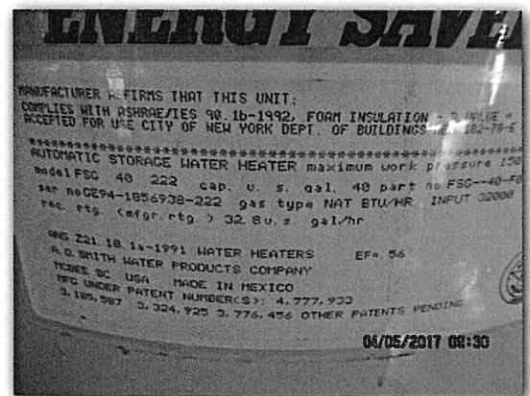
- X No manufacturer recommended safety pan (utility room), which drains to the exterior, under the unit for possible leaks.
- X Temperature and Pressure (T&P) relief valve is terminating in the crawl space. The drain line should run to the exterior of the structure and terminate within 6 inches of the ground.
- X Unable to locate the termination point for the safety drain pan.
- X No water heater vent pipe firestop/support collar in place at the ceiling penetration (laundry room).

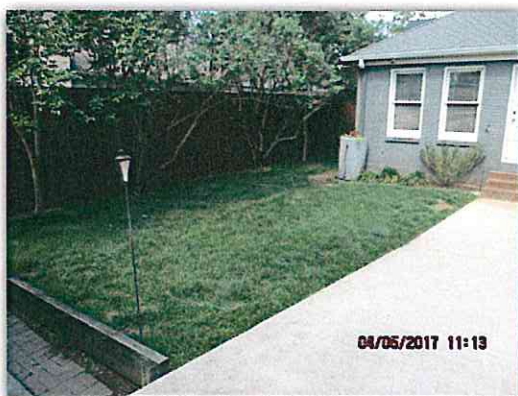
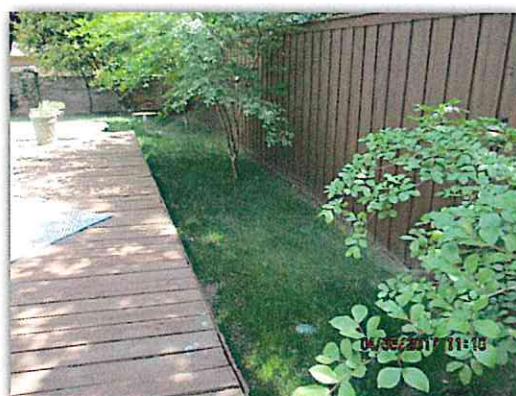
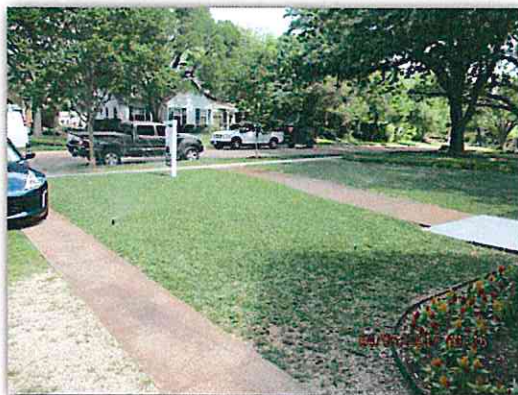
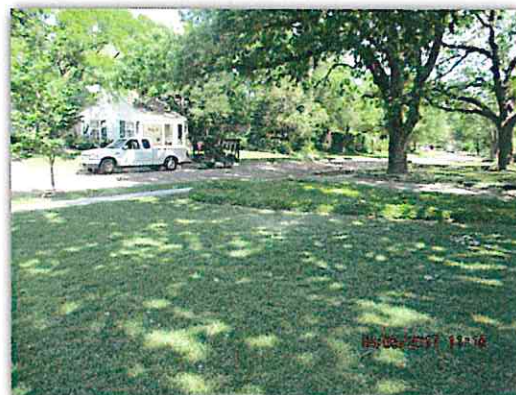
✗ Did not observe any type of rain sensor/ freeze sensor which disables scheduled watering programs when it has been raining or in freezing temperatures.
