TEXAS OFFICIAL WOOD DESTROYING INSECT REPORT

1234 Easy Street

5. Multi-Family Residence, Pier & Beam, Brick & Wood.
 List structure(s) inspected that may include residence, detached garages and other structures on the property. (Refer to Part A, Scope of Inspection)

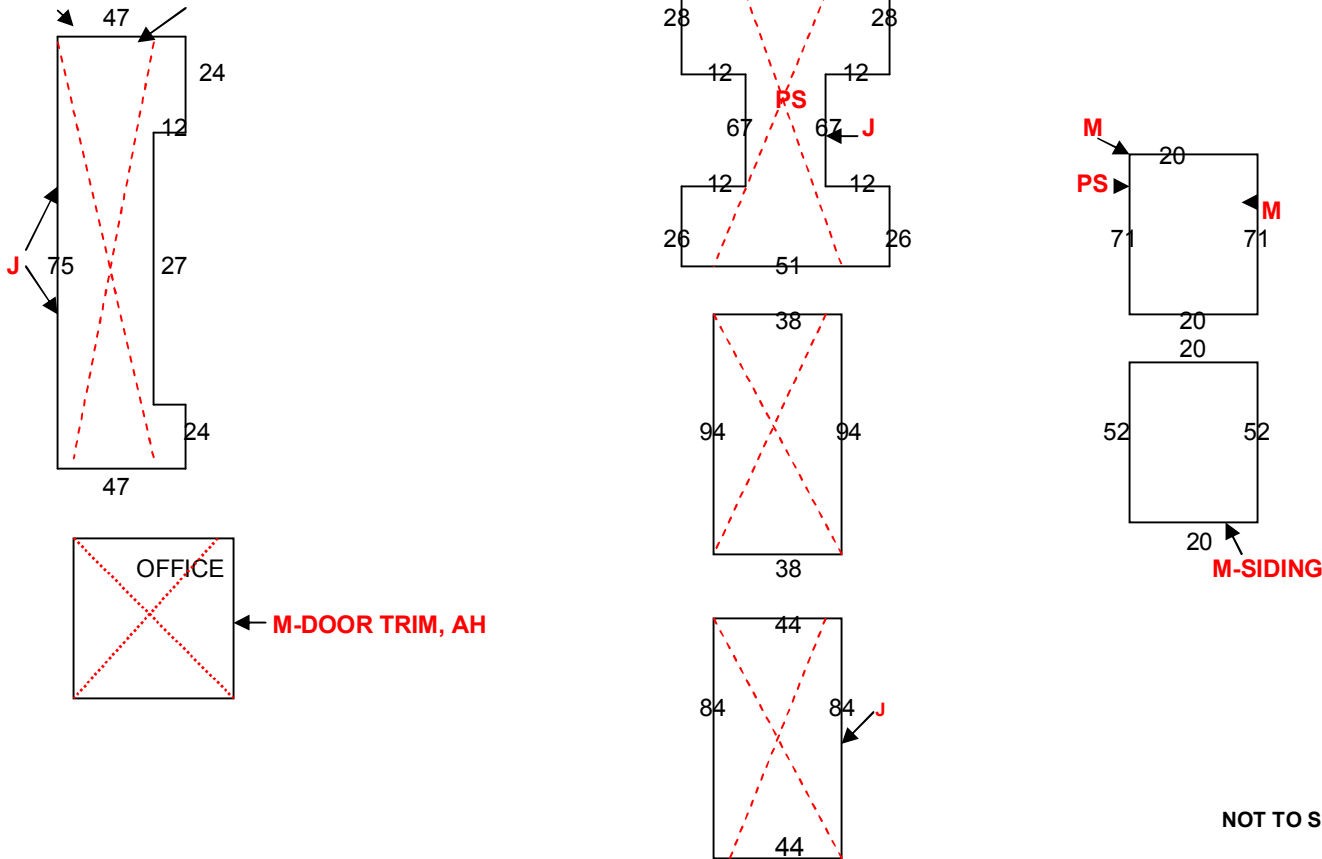
Diagram of Structure(s) Inspected

8G. Visible evidence of: Previous Termite Infestation, Active Carpenter Ant Infestation has been observed in the following areas: Interior walls of Apartment Units, Workshop and Active Carpenter Ants and damage at door frames of building 3517

I-FORMBOARD M-DOOR TRIM

Additional Comments Active Carpenter Ant Infestation. Treatment Recommended. Previous Termite Infestation with no signs of treatment, Treatment Recommended or previous treatment document by licensed pest control company.

9B. A preventive treatment and/or correction of conducive conditions as identified in 7A & 7B is recommended as follows: Yes No
 Specify reason: I-form Board, M-Wood Rot, J-Excessive Moisture
 Refer to Scope of Inspection Part J
