BURGESS INSPECTION GROUP, INC.

PROPERTY INSPECTION REPORT

STRUCTURE WAS: Single-Story Commercial

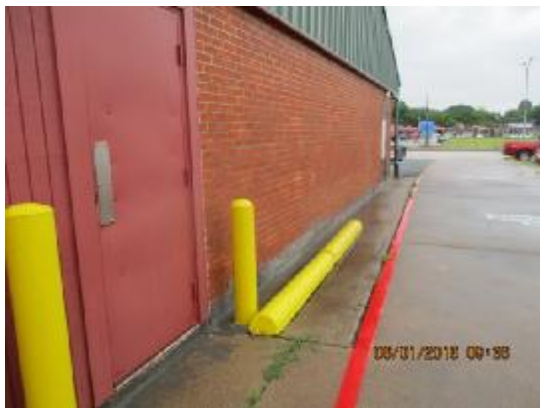
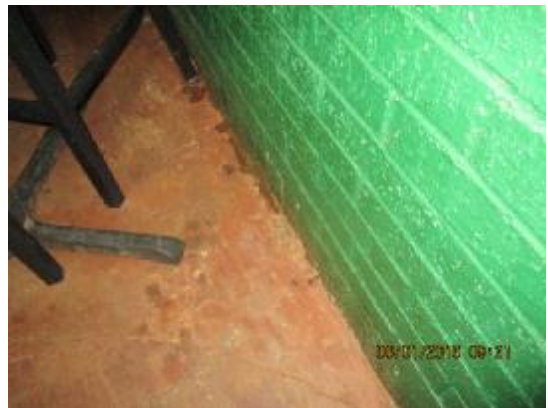
Deficient Item(s): Grading & Drainage

- x The walkway/sidewalk slopes toward the structure on the left side. This represents negative drainage that requires monitoring to ensure runoff water is diverted off the walkway/sidewalk and away from the foundation.

- x The walkway/sidewalk slopes toward the structure on the left side. This represents negative drainage that requires monitoring to ensure runoff water is diverted off the walkway/sidewalk and away from the foundation.

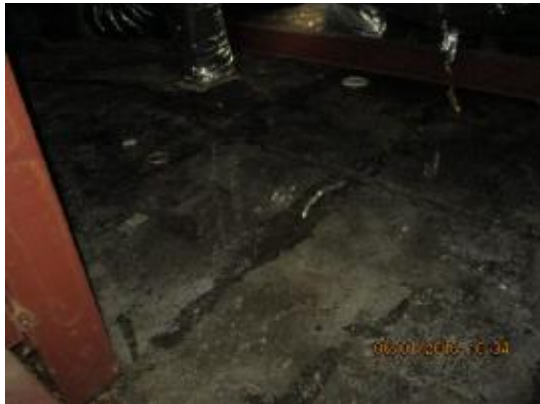
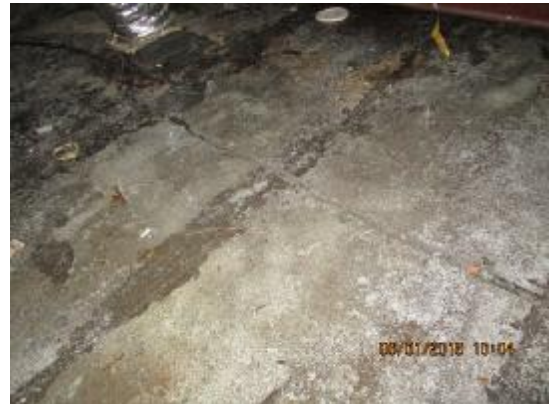
Deficient Item(s): Roof Covering Materials

- x The metal roofing is leaking into the attic space below. I recommend that a Roofer inspect and make any suggestions on repair. Alex with Fireman Roofing is one roofer you can call. 817-455-5618

- x The metal roofing is leaking into the attic space below. I recommend that a Roofer inspect and make any suggestions on repair. Alex with Fireman Roofing is one roofer you can call. 817-455-5618

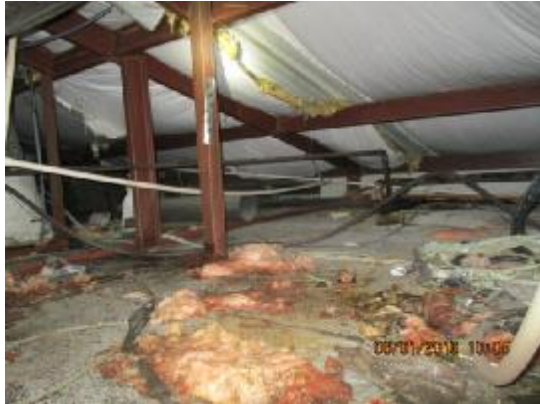
Deficient Item(s): Roof Structure & Attic

- x The insulation on the steal panels has come loose and hanging from various locations. Some of the insulation is wet where the roof appears to have been leaking.

- x The insulation on the steal panels has come loose and hanging from various locations. Some of the insulation is wet where the roof appears to have been leaking.

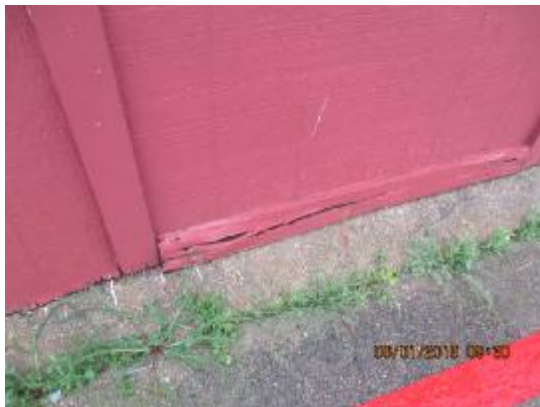
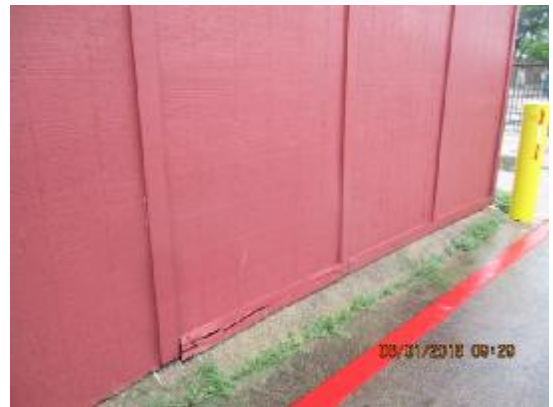
Deficient Item(s): Walls (Interior & Exterior)

- x Signs of previous termite infestation and damage at storage room.
- x Observed previous repairs to exterior masonry.
- x No weepholes in place at bottom of exterior masonry.
- x Rot at siding at right and back side
- x Rot at trim at right side

- x Signs of previous termite infestation and damage at storage room.
- x Observed previous repairs to exterior masonry.
- x No weepholes in place at bottom of exterior masonry.
- x Rot at siding at right and back side
- x Rot at trim at right side

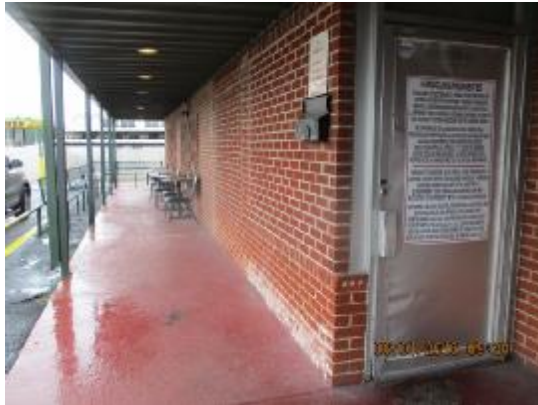
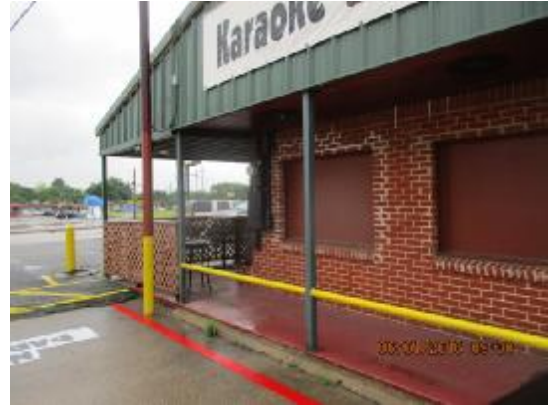
K. Porches, Balconies, Decks and Carports

- ✓ All cement slabs, (garages, porches, patios, driveways, home under floor coverings) can have small surface cement cracks. Generally these cracks are less than 1/8 inch wide and are shrinkage cracks.
- ✓ The porch/patio appears to be in reasonable condition.

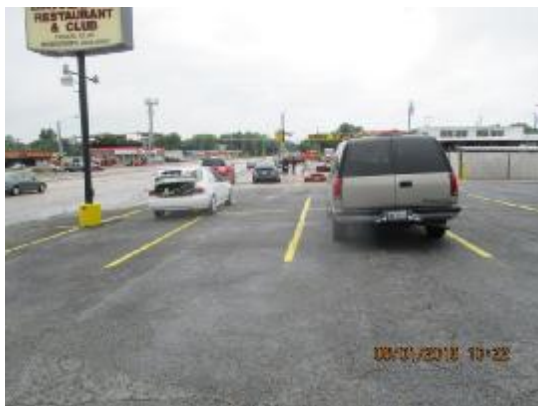
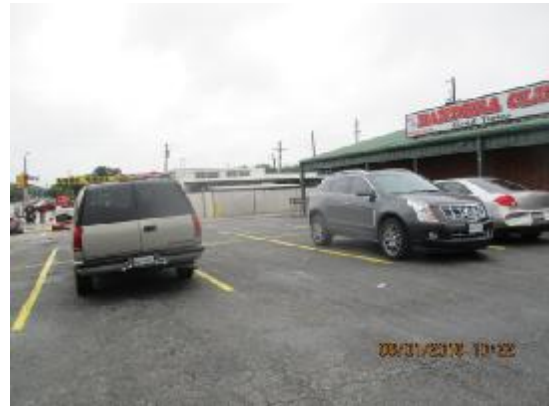
L. Other

- ✓ The parking lot was in reasonable condition. No Handicap spot marked.
- ✓ The marquee was in good shape at time of inspection.

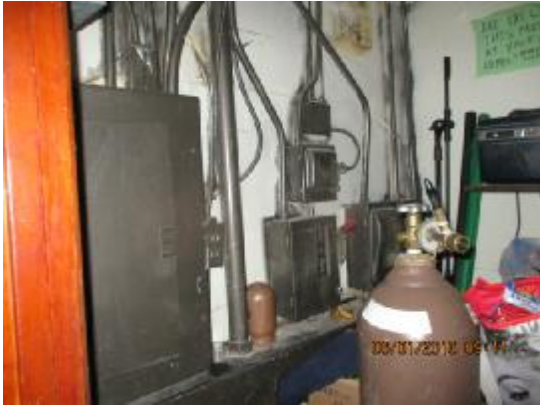
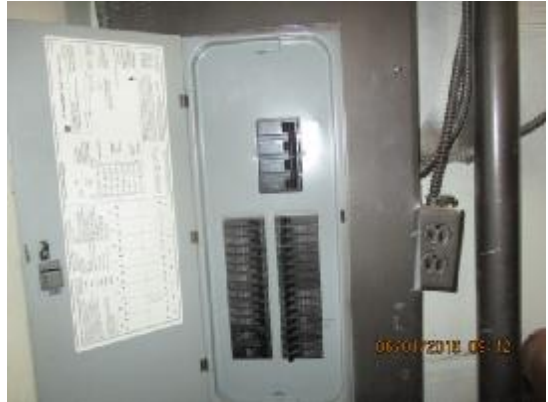
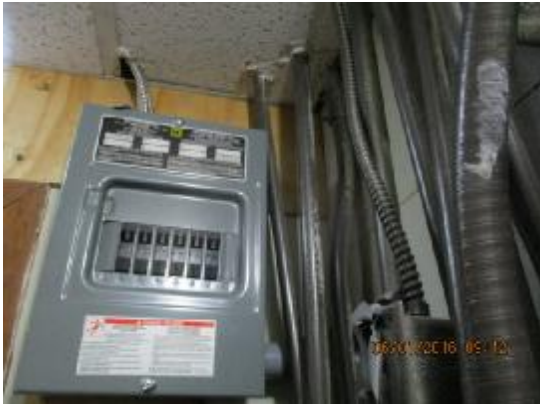
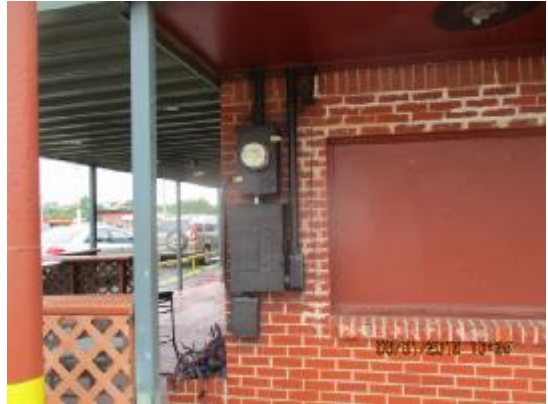
A. Service Entrance and Panels

- ✓ Main panel appears to be properly wired and grounded at this time.

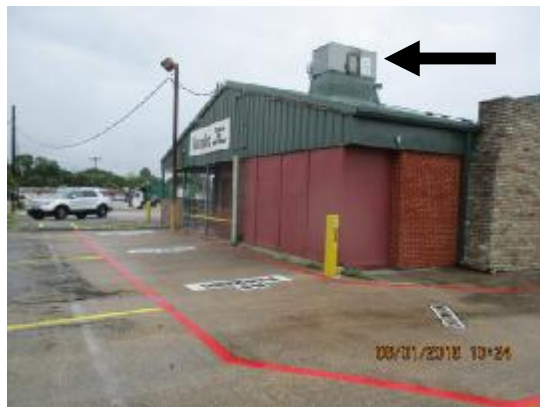
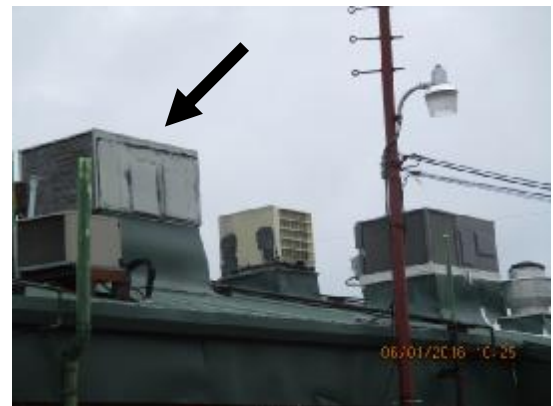
Deficient Item(s): Cooling Equipment

- ✓ Only the far left side unit was working at time of inspection.

- x Two of the cooling units were inoperative at the time of the inspection. Recommend the system be checked by a qualified HVAC technician for any service and/or repair that may be required.

- x Two of the cooling units were inoperative at the time of the inspection. Recommend the system be checked by a qualified HVAC technician for any service and/or repair that may be required.

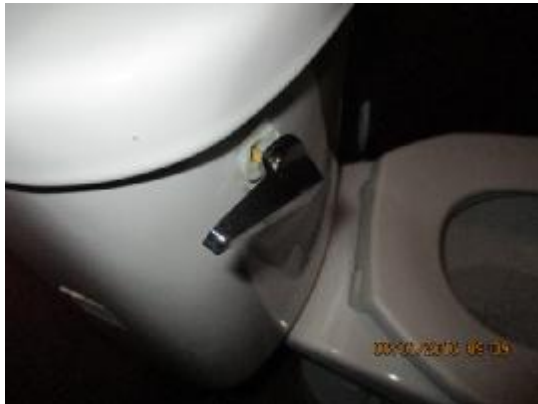
Deficient Item(s): Water Supply System & Fixtures

- x The commode flush handle in the ladies bathroom is damaged.
- x Commode "runs" (water not completely shutting off all the time), due to broken handle in ladies room.
- x Bathrooms are not ADA approved

- x The commode flush handle in the ladies bathroom is damaged.
- x Commode "runs" (water not completely shutting off all the time), due to broken handle in ladies room.
- x Bathrooms are not ADA approved

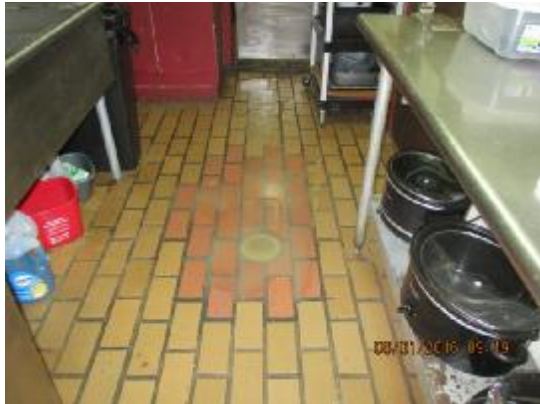
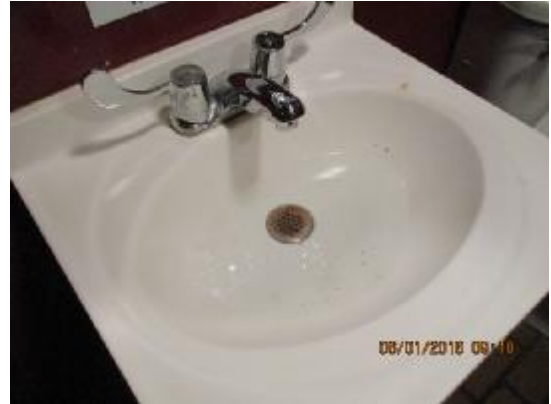
Deficient Item(s): Drains, Wastes, Vents

- x Sink is slow draining at ladies bathroom.
- x The floor drain is clogged in the kitchen area.
- x Recommend having the plumbing checked/repared by a qualified, licensed plumber.

- x Sink is slow draining at ladies bathroom.
- x The floor drain is clogged in the kitchen area.
- x Recommend having the plumbing checked/repared by a qualified, licensed plumber.
