# BURGESS INSPECTION GROUP, INC.

## PROPERTY INSPECTION REPORT

**Concerning:** Anywhere  
(Address or Other Identification of Inspected Property)

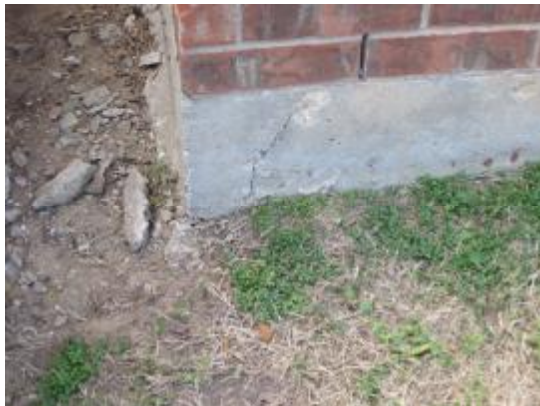
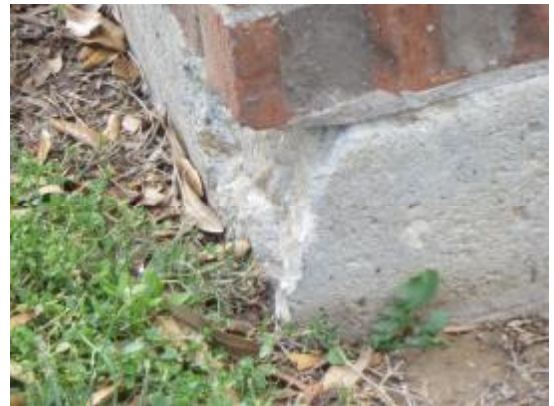
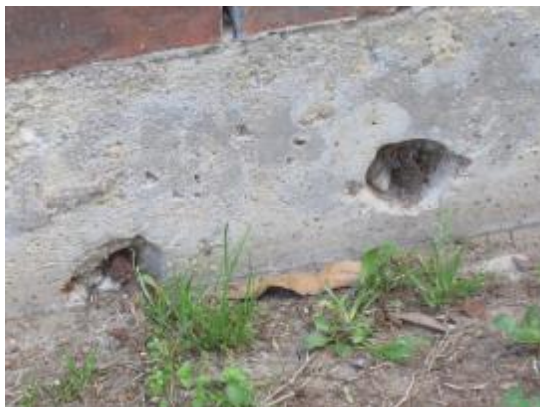
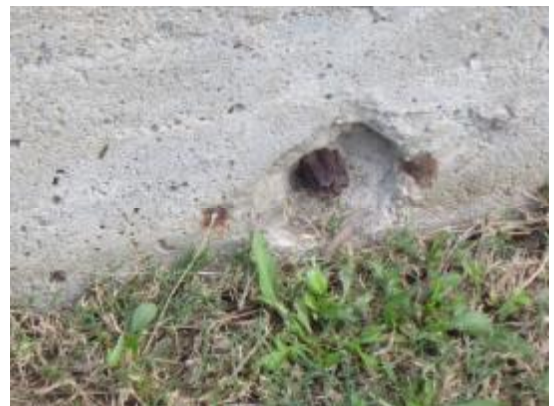
#### Deficient Item(s): Foundation

- x Observed foundation corner wedge cracks/pops in one or more places; not structurally significant.
- x Post-tensioned cable ends are exposed. These need to be sealed to prevent further corrosion and/or rusting.

- x Observed foundation corner wedge cracks/pops in one or more places; not structurally significant.
- x Post-tensioned cable ends are exposed. These need to be sealed to prevent further corrosion and/or rusting.

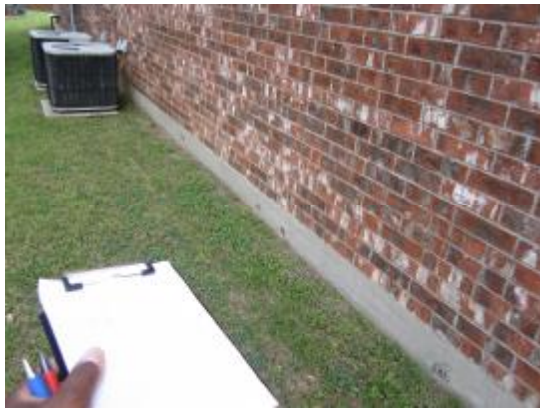
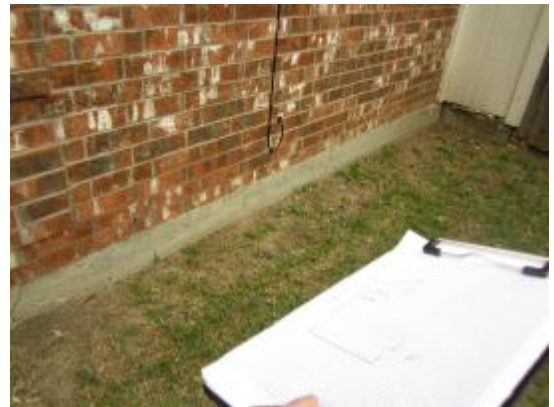
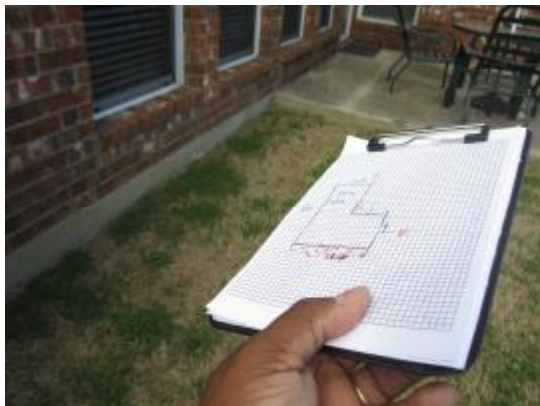
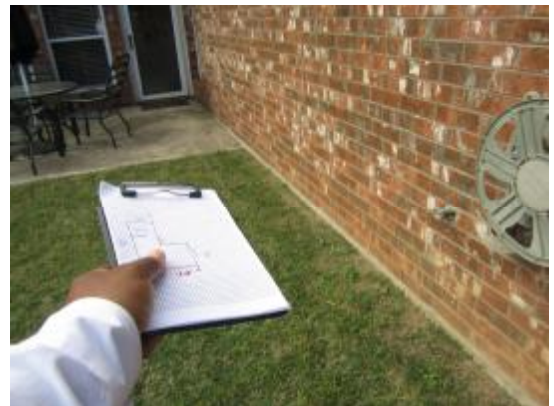
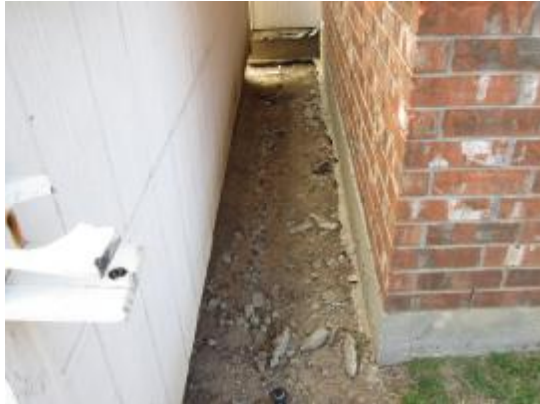
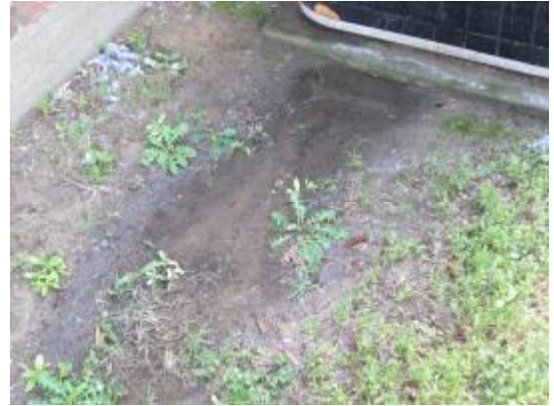
**Deficient Item(s): Grading & Drainage**

- x Soil washout is happening under the roofline at the left, right and rear of the home. If not corrected this can result in flat drainage or lead to water ponding/pooling next to slab.
- x The foundation footer is exposed; soil line is too low at the right side next to the shed. Lack of sufficient soil, sod and grading around a foundation can be a detriment to the foundation because improper drainage can lead to the foundation not performing as intended.
- x Observed area where water is ponding at the left side by the a/c unit.

- x Soil washout is happening under the roofline at the left, right and rear of the home. If not corrected this can result in flat drainage or lead to water ponding/pooling next to slab.
- x The foundation footer is exposed; soil line is too low at the right side next to the shed. Lack of sufficient soil, sod and grading around a foundation can be a detriment to the foundation because improper drainage can lead to the foundation not performing as intended.
- x Observed area where water is ponding at the left side by the a/c unit.

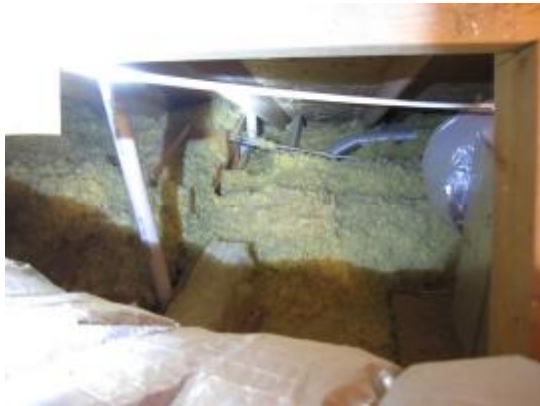
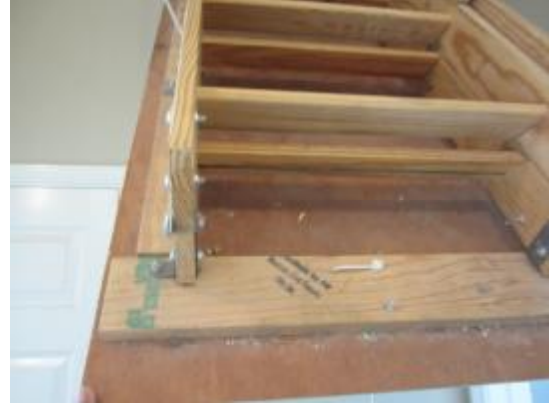
**Deficient Item(s): Roof Structure & Attic**

- x Observed signs of pests (rodents) in attic (trails). Pests have been known to damage various attic components.
- x The attic access ladder should have weather-stripping around the perimeter and should close up securely at the ceiling opening. This helps the ladder to act as a fire-blocking agent.

- x Observed signs of pests (rodents) in attic (trails). Pests have been known to damage various attic components.
- x The attic access ladder should have weather-stripping around the perimeter and should close up securely at the ceiling opening. This helps the ladder to act as a fire-blocking agent.

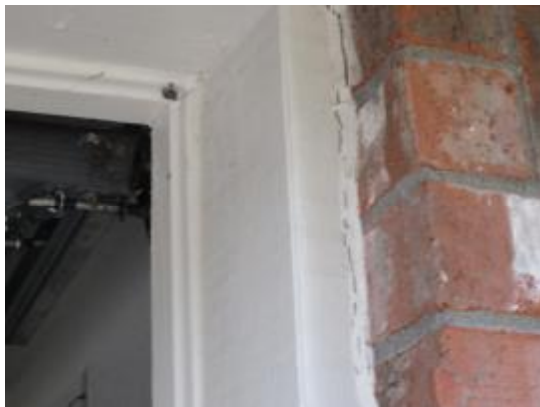
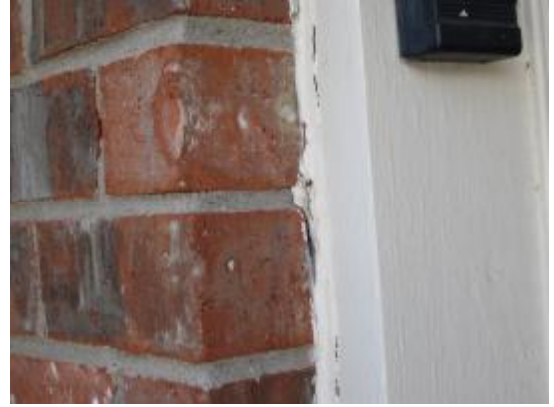
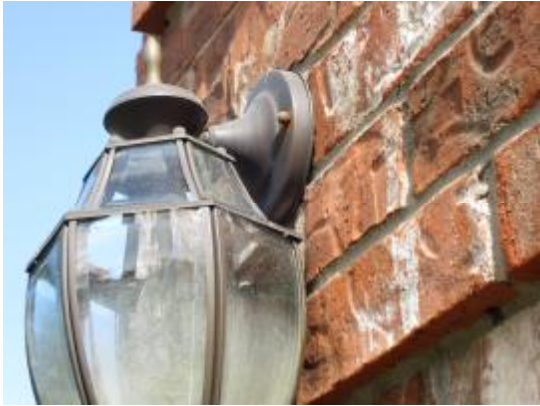
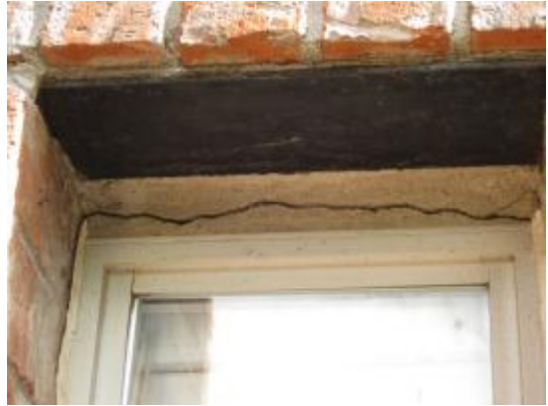
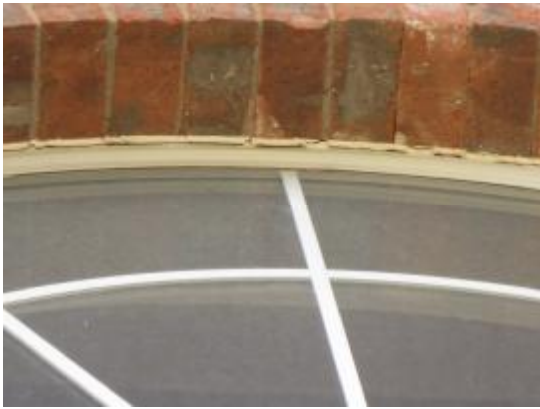
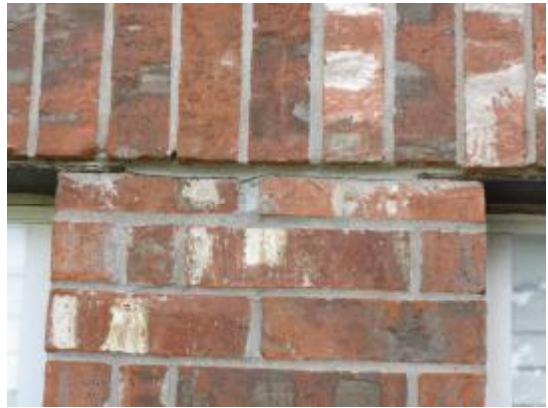
**Deficient Item(s): Walls (Interior & Exterior)**

- x Open spots/separations in brick mortar that need sealing in one or more places. These do not appear to be structurally significant and would just need pointing-up if desired.
- x Observed a little separation at the garage door trimmers; these gaps should be caulked and sealed to prevent pest infestation.
- x Caulking maintenance needed in one or more places at the exterior, i.e., around exterior wall lights, at some or all windows; should be sealed against water penetration.

- x Open spots/separations in brick mortar that need sealing in one or more places. These do not appear to be structurally significant and would just need pointing-up if desired.
- x Observed a little separation at the garage door trimmers; these gaps should be caulked and sealed to prevent pest infestation.
- x Caulking maintenance needed in one or more places at the exterior, i.e., around exterior wall lights, at some or all windows; should be sealed against water penetration.

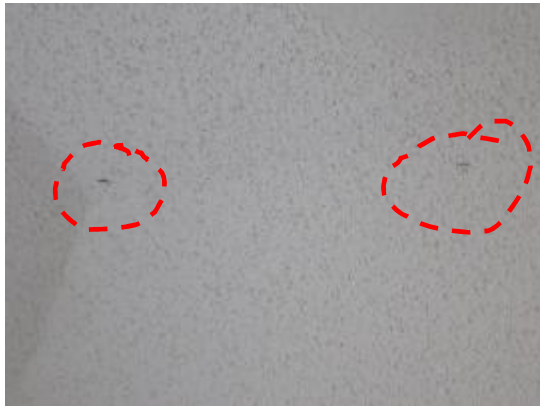
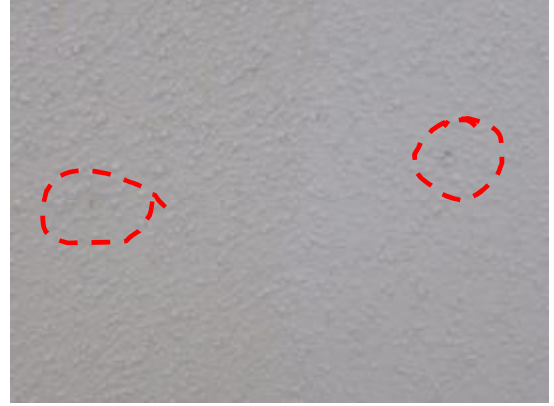
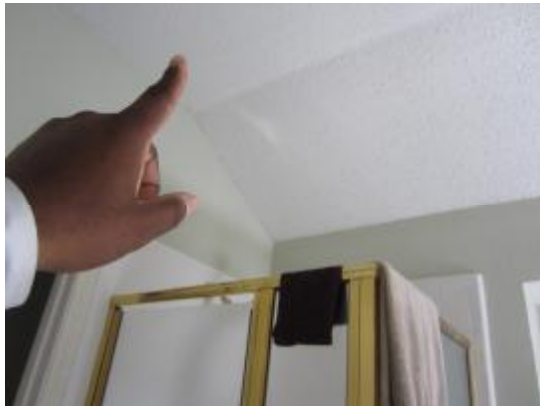
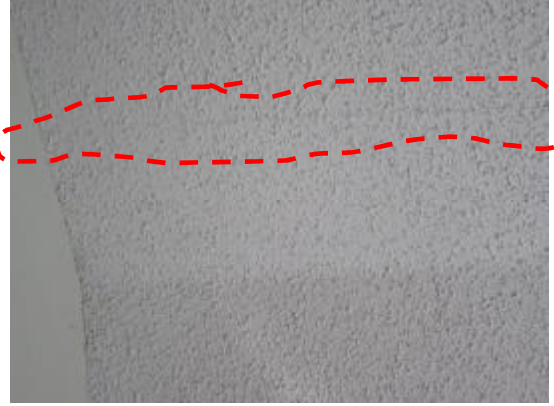
**Deficient Item(s): Ceilings & Floors**

- x Observed previously patched/repared area on ceiling.
- x Observed random nail-pops on some of the ceilings; these are typically cosmetic items.
- x Observed tape/shrinkage cracks in the ceiling(s) in kitchen; these do not appear to be structurally significant.

- x Observed previously patched/repared area on ceiling.
- x Observed random nail-pops on some of the ceilings; these are typically cosmetic items.
- x Observed tape/shrinkage cracks in the ceiling(s) in kitchen; these do not appear to be structurally significant.

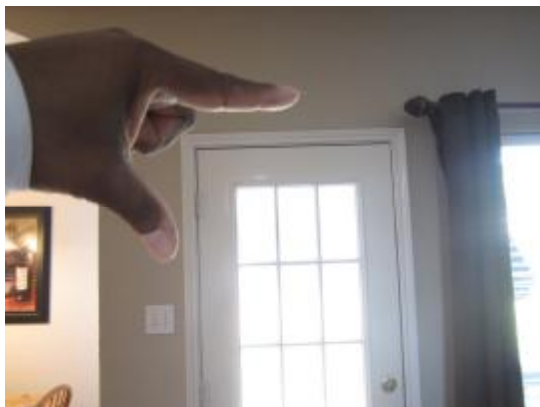
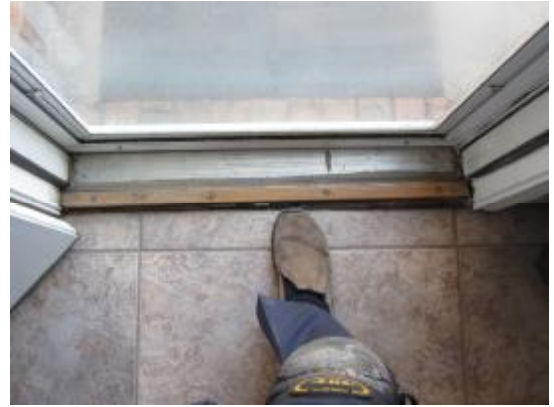
**Deficient Item(s): Doors (Interior & Exterior)**

- x Door frame is a little out-of-square at the rear patio exit.
- x Observed that the threshold at the rear patio exit door has evidence of moisture penetration. This should be repaired/replaced and sealed against future moisture penetration.

- x Door frame is a little out-of-square at the rear patio exit.
- x Observed that the threshold at the rear patio exit door has evidence of moisture penetration. This should be repaired/replaced and sealed against future moisture penetration.

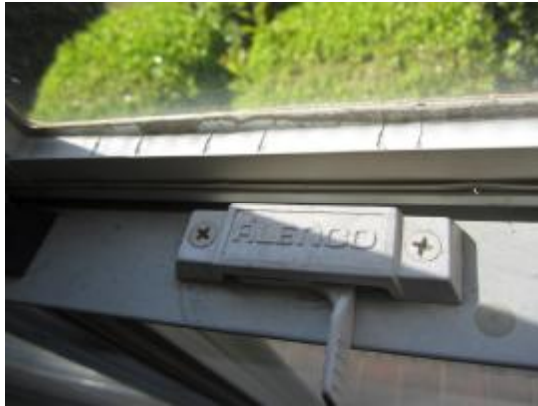
**Deficient Item(s): Windows**

- x At the exterior: window glazing bead is deteriorated/has small splits in various locations.

- x At the exterior: window glazing bead is deteriorated/has small splits in various locations.

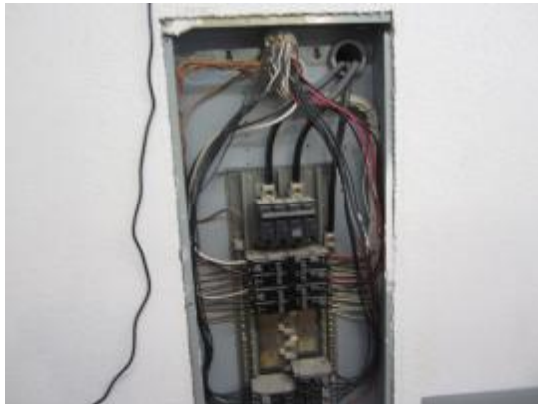
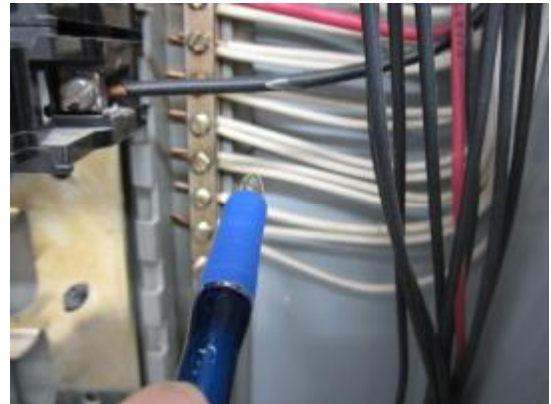
**Deficient Item(s): Service Entrance & Panels**

- x Observed at least two wires "doubled tapped" (two wires under one connection) at a neutral and ground bars.

- x Observed at least two wires "doubled tapped" (two wires under one connection) at a neutral and ground bars.

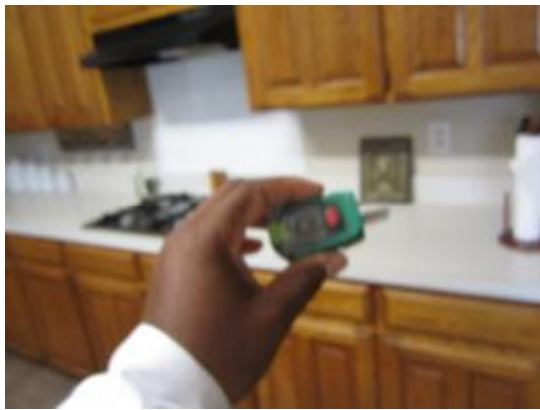
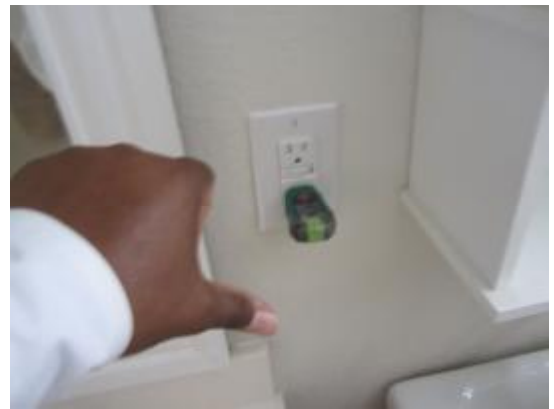
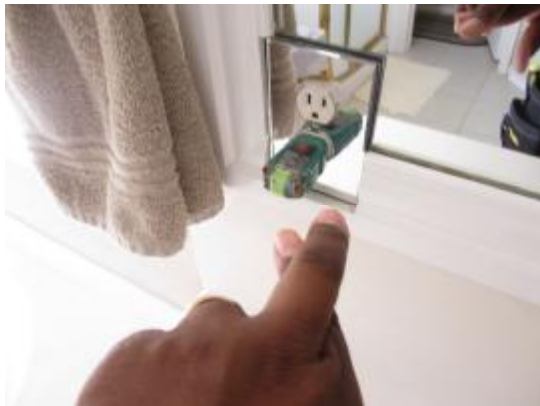
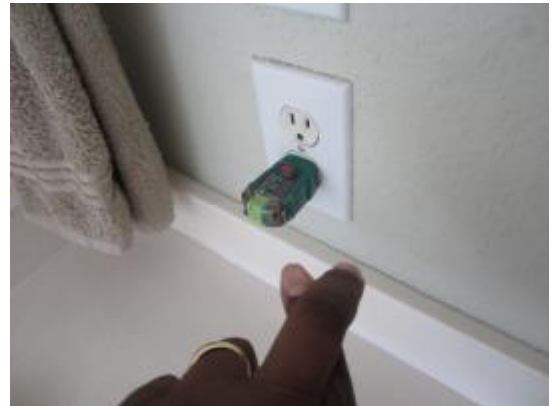
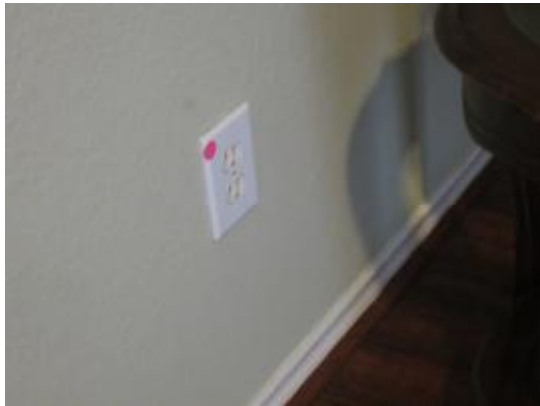
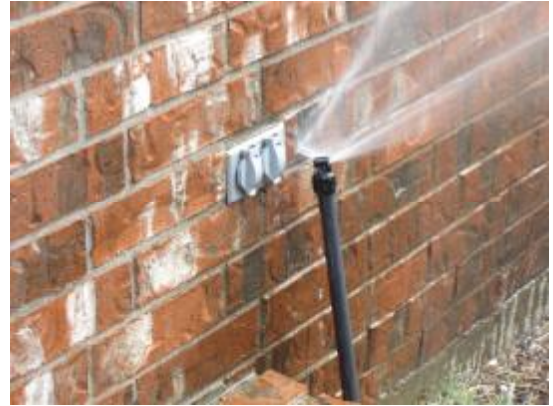
**Deficient Item(s): Connected Devices & Fixtures**

- x Some of the kitchen counter receptacles are not protected by Ground Fault Circuit Interrupters (GFCI's). Since 2000 *all* counter receptacles in the kitchen are required to be GFCI protected. (See TREC Notice on page 2 of this report)
- x The Ground Fault Circuit Interrupter (GFCI) receptacle in the hall bath has no power; the external tester does not light up when plugged in to the outlet.
- x Outlet with Hot/Neutral reversed (incorrect polarity) at the master bath.
- x Wall outlet(s) loose in one or more places may just need tightening; see sticker dots.
- x Exterior receptacle in wet locations (front/rear porch) do not have an **in-use** cover (cord can be plugged in while cover is closed).
- x Observed that the smoke alarms are a little loose/not mounted flush against the ceiling in one or more places.

- x Some of the kitchen counter receptacles are not protected by Ground Fault Circuit Interrupters (GFCI's). Since 2000 all counter receptacles in the kitchen are required to be GFCI protected. (See TREC Notice on page 2 of this report)
- x The Ground Fault Circuit Interrupter (GFCI) receptacle in the hall bath has no power; the external tester does not light up when plugged in to the outlet.
- x Outlet with Hot/Neutral reversed (incorrect polarity) at the master bath.
- x Wall outlet(s) loose in one or more places may just need tightening; see sticker dots.
- x Exterior receptacle in wet locations (front/rear porch) do not have an in-use cover (cord can be plugged in while cover is closed).
- x Observed that the smoke alarms are a little loose/not mounted flush against the ceiling in one or more places.

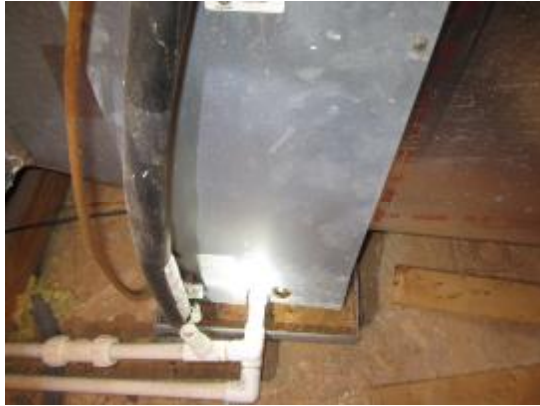
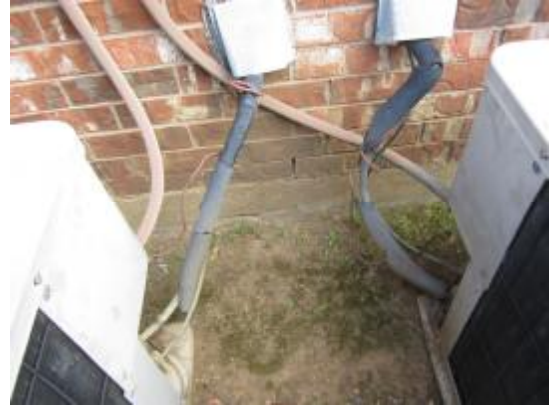
**Deficient Item(s): Cooling Equipment**

- x The attic safety secondary drain pan has a rust buildup, but no water at this time. This indicates that the pan has held water in the past and should be closely monitored for clogged primary condensate drain line.
- x Coolant line insulation is missing/deteriorating at outside condensing units.

- x The attic safety secondary drain pan has a rust buildup, but no water at this time. This indicates that the pan has held water in the past and should be closely monitored for clogged primary condensate drain line.
- x Coolant line insulation is missing/deteriorating at outside condensing units.

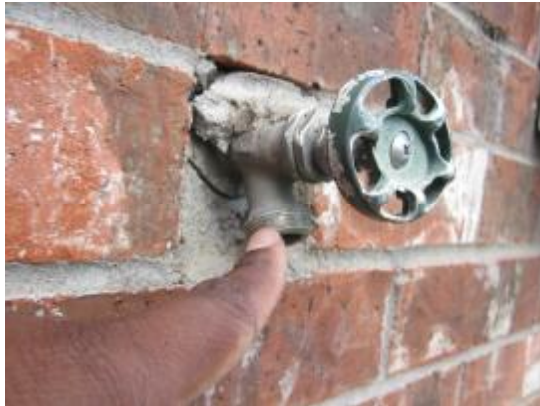
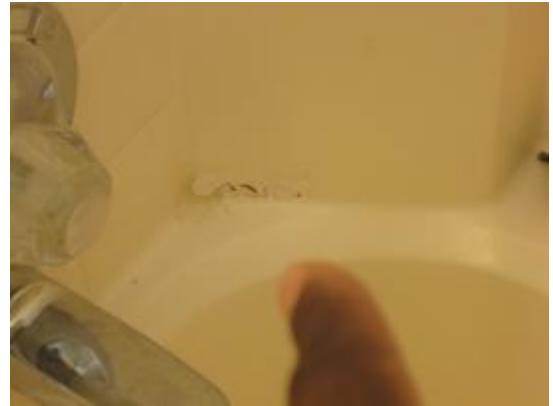
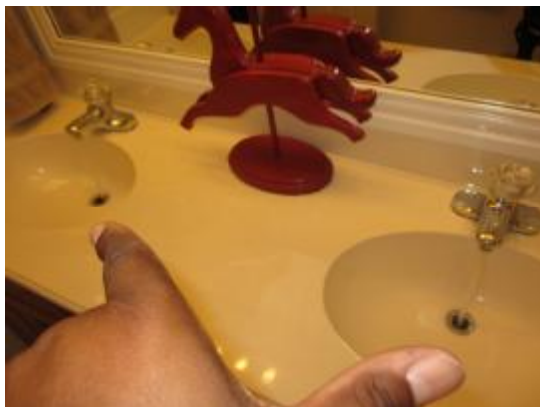
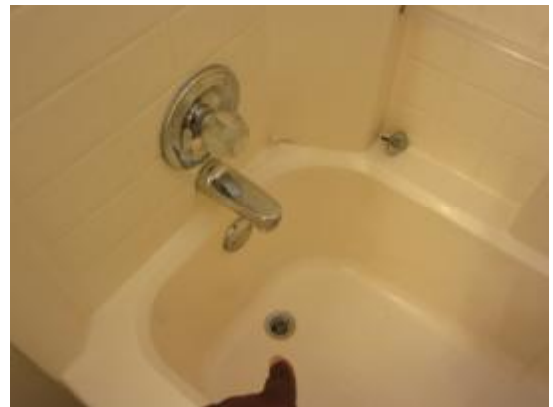
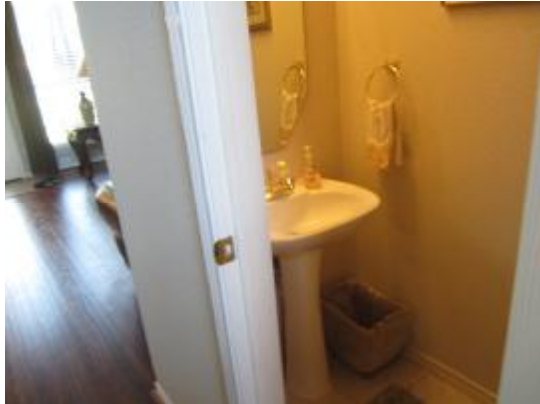
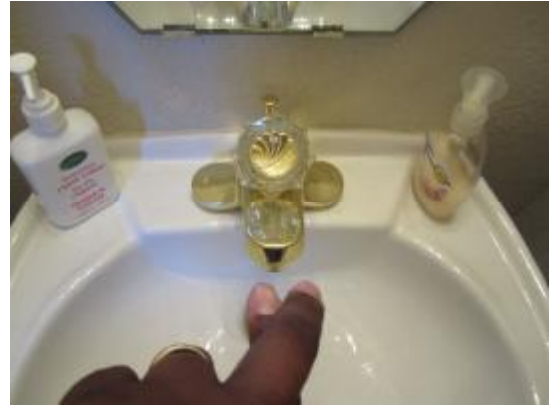
**Deficient Item(s): Water Supply System & Fixtures**

- x The exterior hose faucet(s) are not equipped with backflow prevention devices to insure water cannot be siphoned back into the home. (See TREC Notice on page 2 of this report)
- x The exterior water spicket has stripped threads; cannot connect water hose.
- x Observed that the fiberglass tub/shower kit has some damage.
- x No sink drain stopper in place at the JJ sinks in the master bath.
- x The hot and cold water supply connections are reversed at the powder bath sink.
- x Tub stopper is loose, not functioning as intended at the master bath.

- x The exterior hose faucet(s) are not equipped with backflow prevention devices to insure water cannot be siphoned back into the home. (See TREC Notice on page 2 of this report)
- x The exterior water spicket has stripped threads; cannot connect water hose.
- x Observed that the fiberglass tub/shower kit has some damage.
- x No sink drain stopper in place at the JJ sinks in the master bath.
- x The hot and cold water supply connections are reversed at the powder bath sink.
- x Tub stopper is loose, not functioning as intended at the master bath.

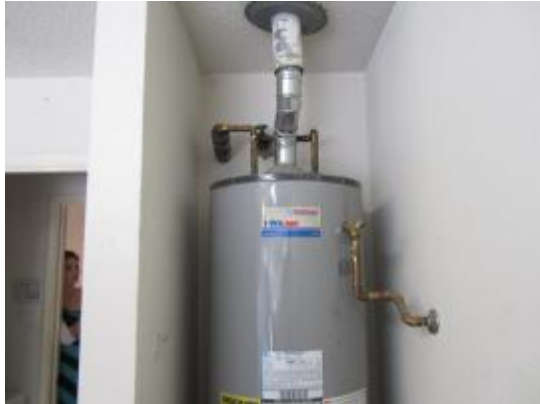
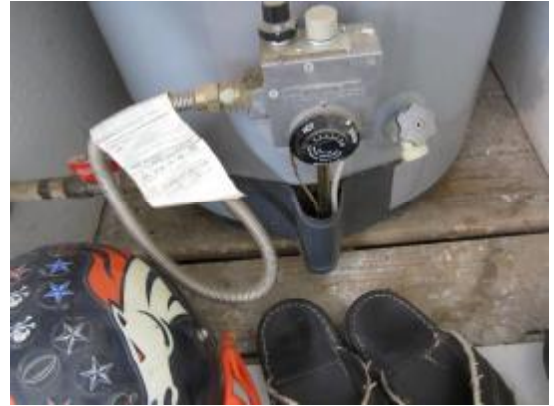
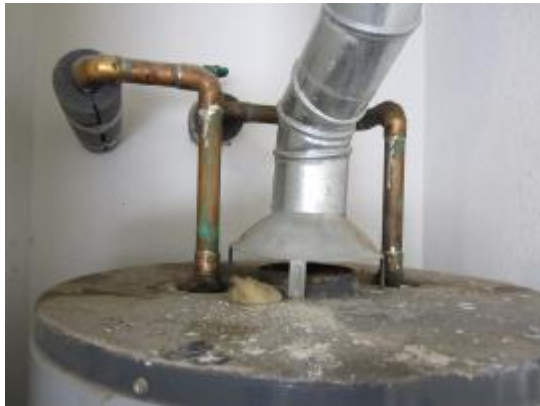
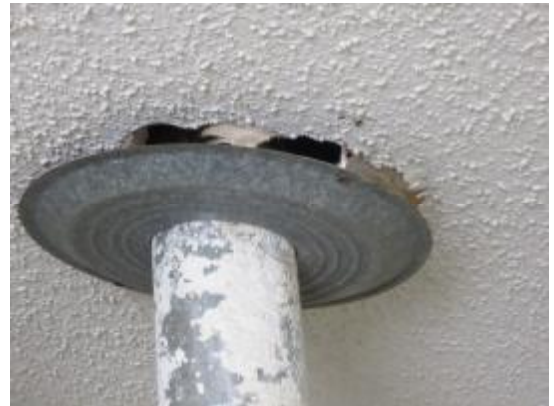
**Deficient Item(s): Water Heating Equipment**

- x No manufacturer recommended safety pan, which drains to the exterior, under the unit for possible leaks.
- x No insulation on water supply lines to a unit located in an area that could be subjected to freezing temperatures.
- x Observed no quick disconnect union on the water supply lines for replacement or service of the water heater.
- x No water heater vent pipe firestop/support collar in place at the ceiling penetration.

- x No manufacturer recommended safety pan, which drains to the exterior, under the unit for possible leaks.
- x No insulation on water supply lines to a unit located in an area that could be subjected to freezing temperatures.
- x Observed no quick disconnect union on the water supply lines for replacement or service of the water heater.
- x No water heater vent pipe firestop/support collar in place at the ceiling penetration.

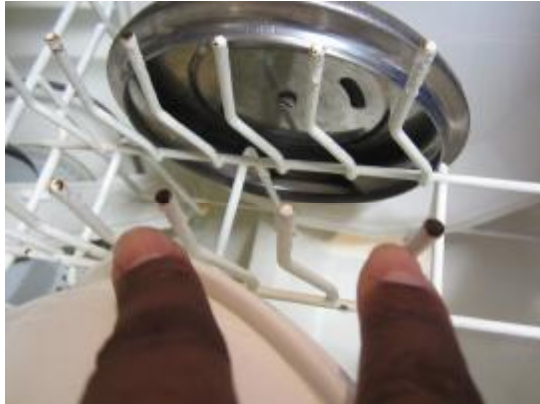
**Deficient Item(s): Dishwasher**

- x Observed rust on the dish rack(s).

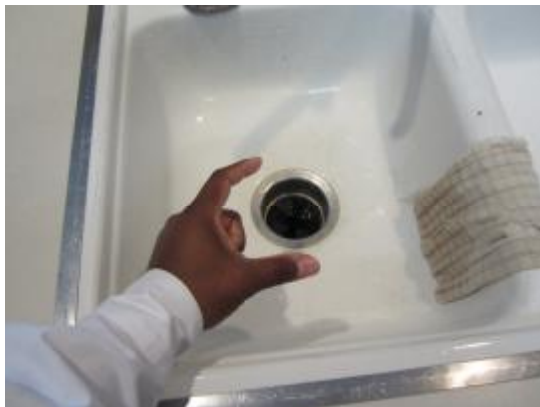
**Deficient Item(s): Food Waste Disposer**

- x The disposer is a little noisy.

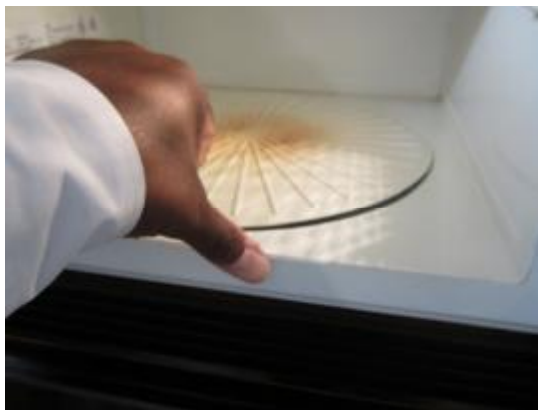
**Deficient Item(s): Microwave Oven**

- x The turntable did not turn.
- x The plate for the turntable is missing.

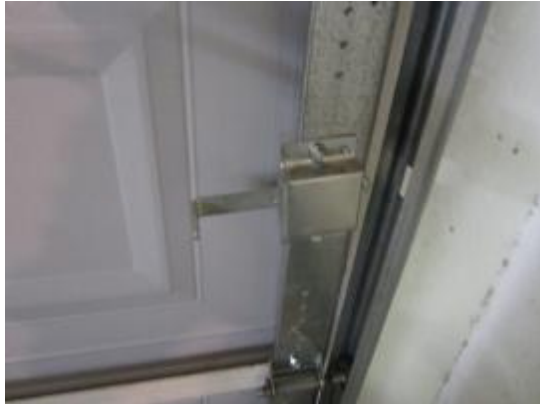
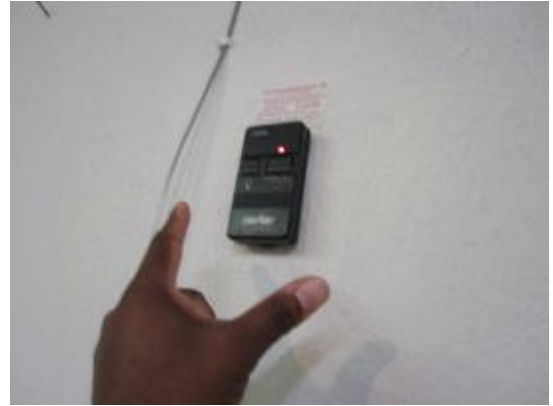
**Deficient Item(s): Garage Door Operators**

- x Manual lock mechanism in place on a garage door(s) with an automatic operator. If the manual lock is engaged and the automatic button is pushed the door can be damaged. The manual lock mechanism should be removed or disabled. (See TREC Notice on page 2 of this report)
- x The garage door opener wall control (button/console) is loose.

- x Manual lock mechanism in place on a garage door(s) with an automatic operator. If the manual lock is engaged and the automatic button is pushed the door can be damaged. The manual lock mechanism should be removed or disabled. (See TREC Notice on page 2 of this report)
- x The garage door opener wall control (button/console) is loose.

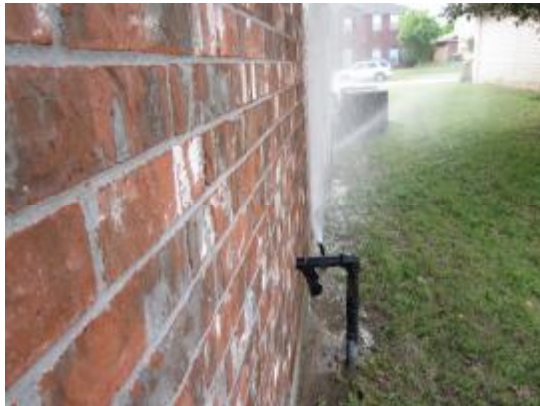
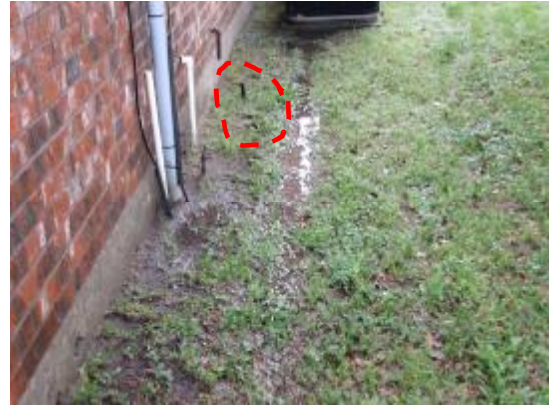
**Deficient Item(s): Lawn and Garden Sprinkler Systems**

- x Possible broken sprinkler water line (water gushing from the ground) observed in one or more places, i.e., at the left side.
- x Some of the heads did not automatically retract/go back down after operation; may just be in need of seasonal maintenance.
- x Suggest a sprinkler professional further evaluate the system for possible repairs and costs.

- x Possible broken sprinkler water line (water gushing from the ground) observed in one or more places, i.e., at the left side.
- x Some of the heads did not automatically retract/go back down after operation; may just be in need of seasonal maintenance.
- x Suggest a sprinkler professional further evaluate the system for possible repairs and costs.

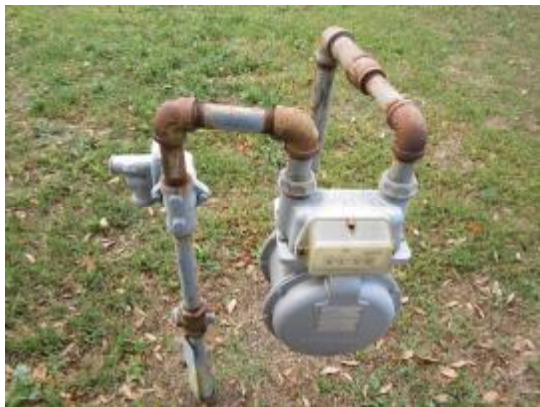
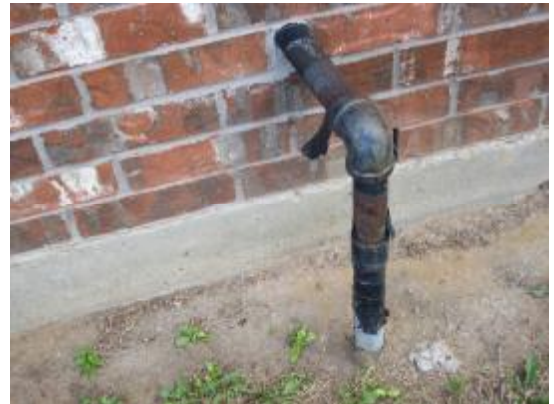
**Deficient Item(s): Gas Supply Systems**

- x Supply pipes at the gas meter have visible rust and needs to be protected with an anti-rust paint.
- x Gas riser pipe at the structure has visible rust and needs to be protected with an anti-rust paint.
